Cornerstone Home Inspection
Bill Ditchey
Mount Carmel, PA 17851
(570)847-8863
ditch@ptd.net

Home Inspection Report

123 Main St.
Any Town, PA

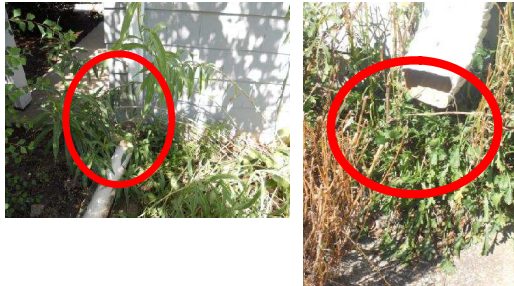
- 1. Method of Inspection: On roof, Ground level
- 2. Acceptable Unable to Inspect:
- 3. Acceptable Material: Asphalt shingle
- 4. Type: Gable
- 5. Approximate Age: 2-3 years
- 6. Acceptable Flashing: Galvanized
- 7. Not Present Valleys:
- 8. Not Present Skylights:
- 9. Acceptable Plumbing Vents: PVC
- 10. Not Present Electrical Mast:
- 11. Acceptable Gutters: Aluminum
- 12. Marginal Downspouts: Aluminum----- (1) Downspout needs to be reconnected
(1) Downspout needs to be diverted away from building

1. Downspouts: Aluminum----- (1) Downspout needs to be reconnected (1) Downspout needs to be diverted away from building

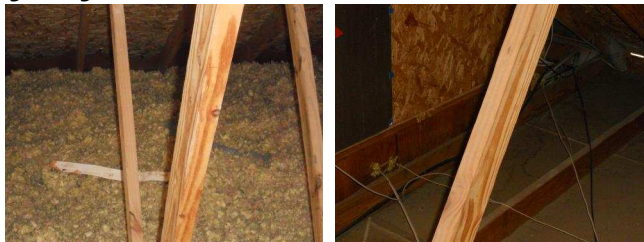
- 1. Method of Inspection: From the attic access
- 2. Unable to Inspect:
- 3. Acceptable Roof Framing:
- 4. Acceptable Sheathing: Plywood
- 5. Acceptable Ventilation: Ridge and soffit vents
- 6. Acceptable Insulation: Fiber fill
- 7. Acceptable Insulation Depth: 6"----- Only insulated above living area not garage area

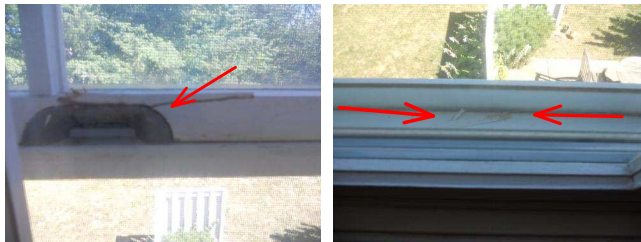
- 1. Acceptable Closet: Walk In
- 2. Acceptable Ceiling: Paint
- 3. Acceptable Walls: Paint
- 4. Acceptable Floor: Hardwood
- 5. Acceptable Doors: Hollow wood
- 6. Marginal Windows: Wood double hung----- Hard operation wood separated at lock area

7. 2nd Floor Master Bedroom Windows: Wood double hung----- Hard operation wood separated at lock area
